Techrete Concrete Pavement Patching on I-215

Interim Report

Experimental Feature X(04)02

***Utah Department of Transportation
Research Division***

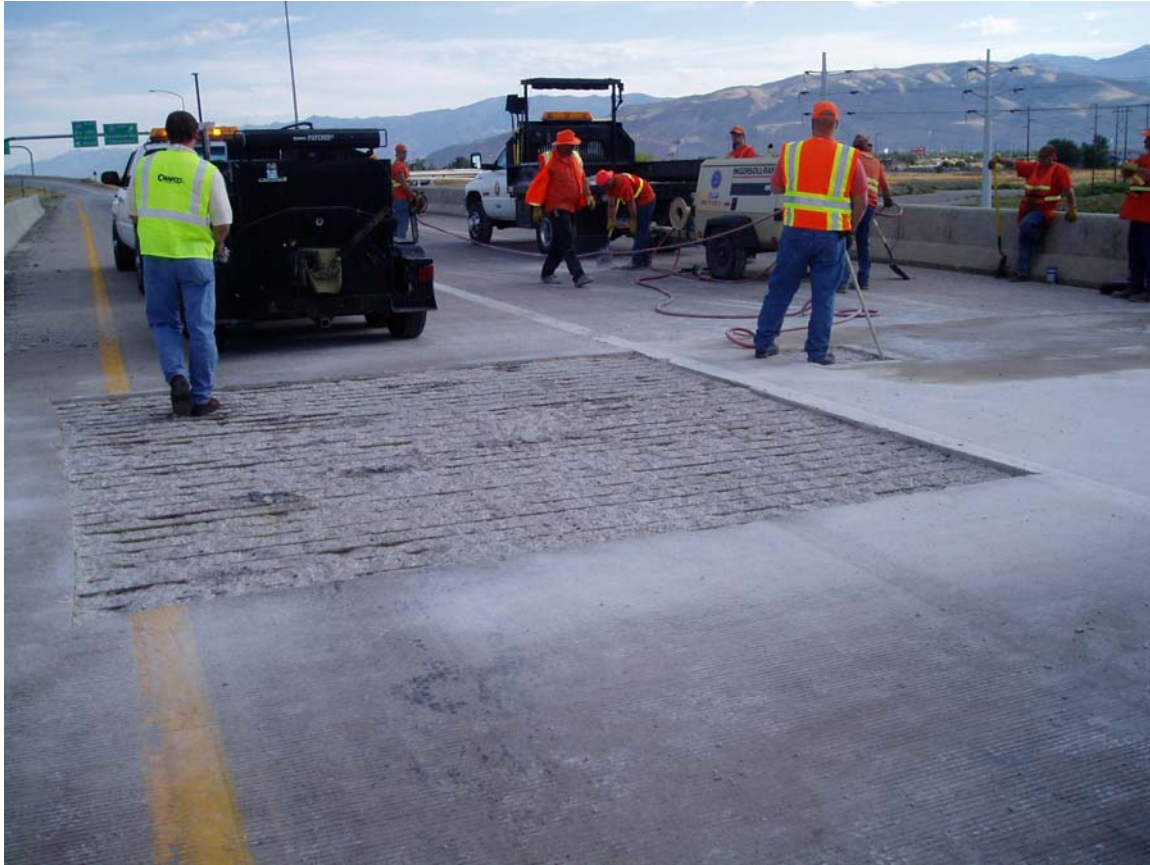
Prep work consisted of saw cutting edges and hammering out the delaminated concrete.

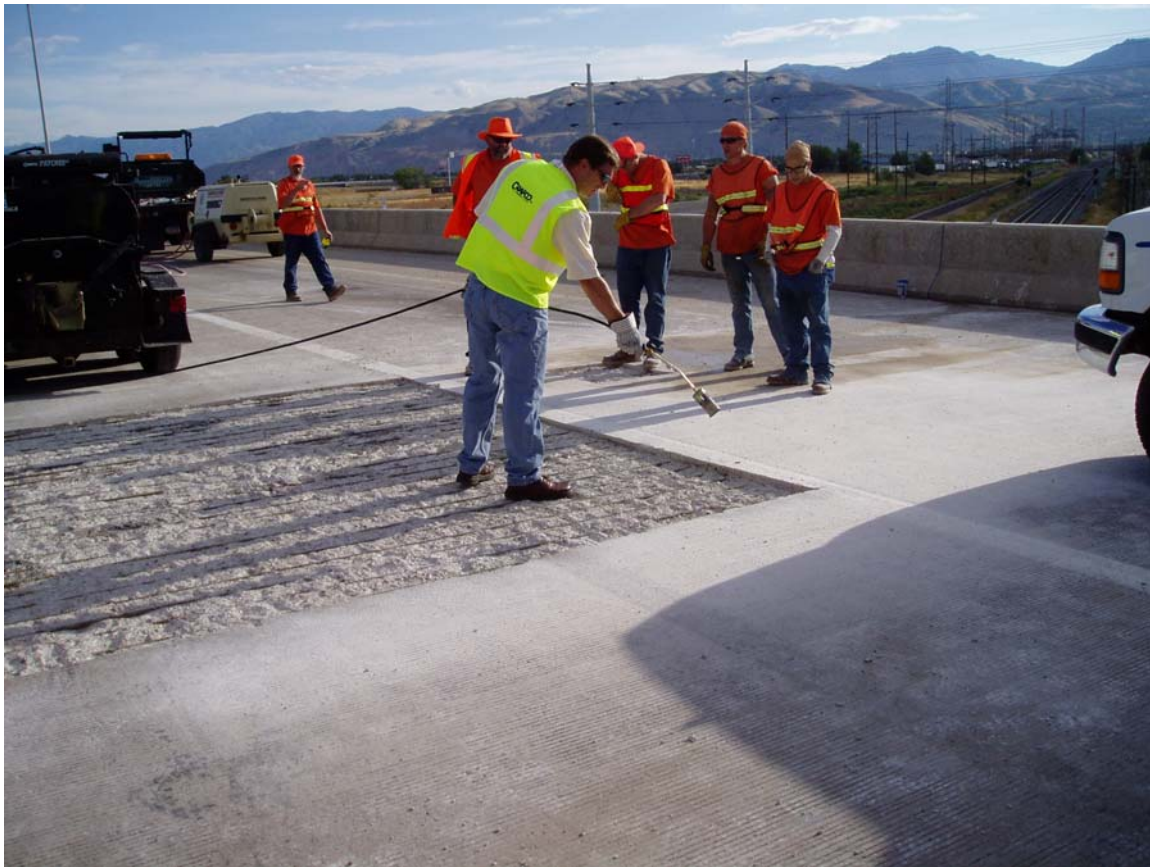
Concrete was heated prior to application of the primer.

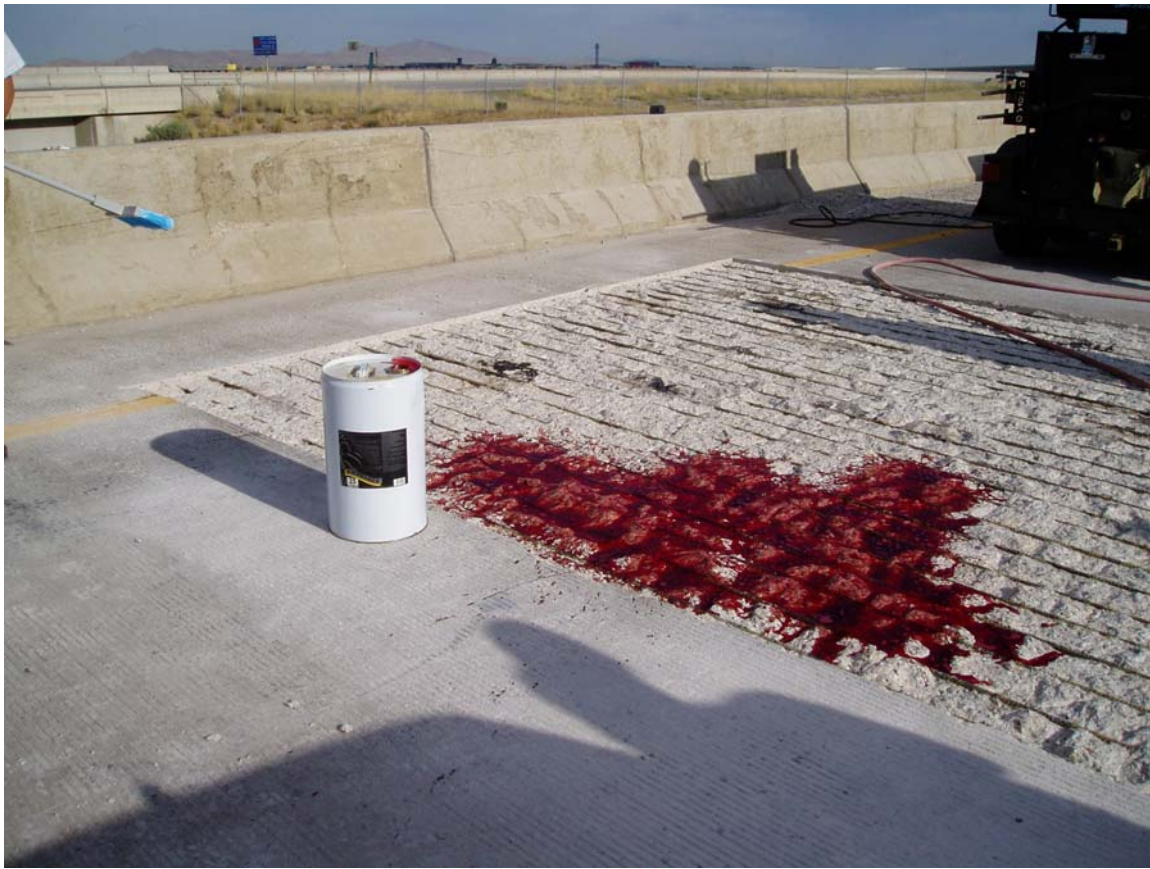
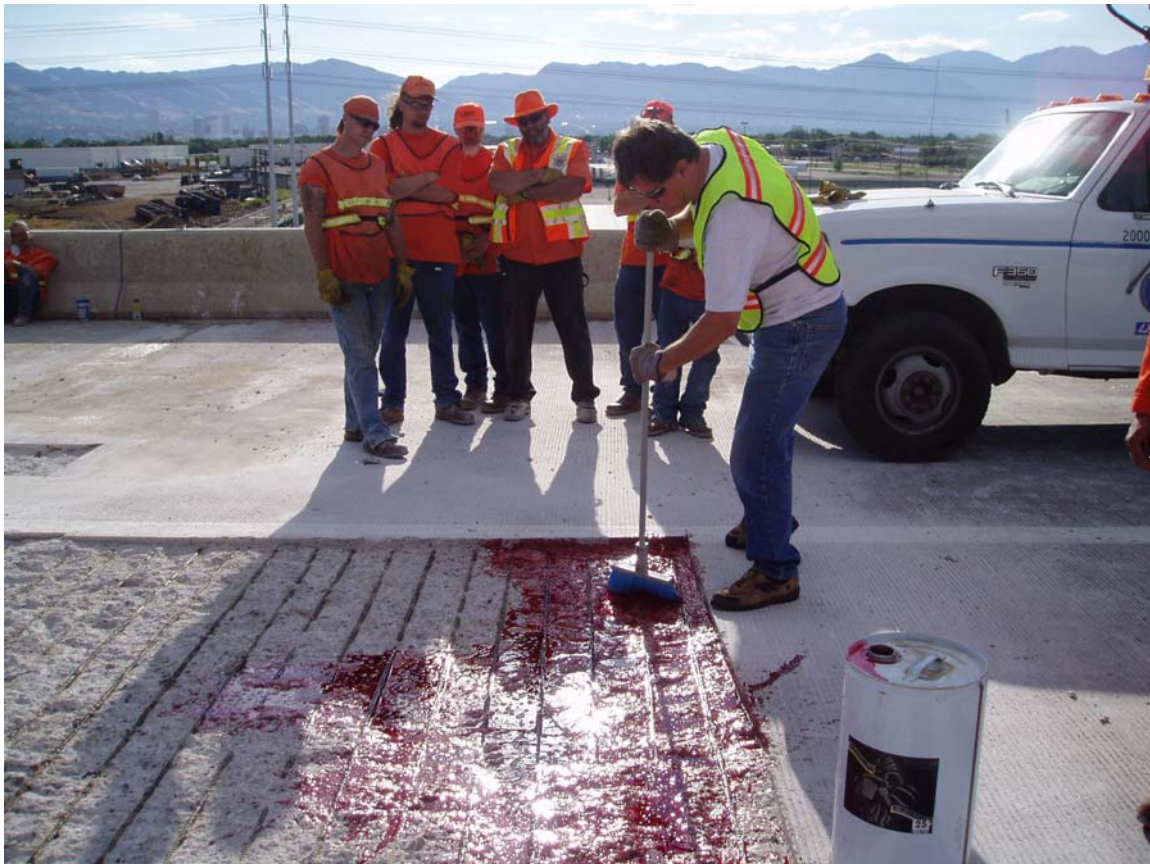
Primer was splashed on, then broomed and brushed in until it fully coated the exposed concrete and reinforcing steel.

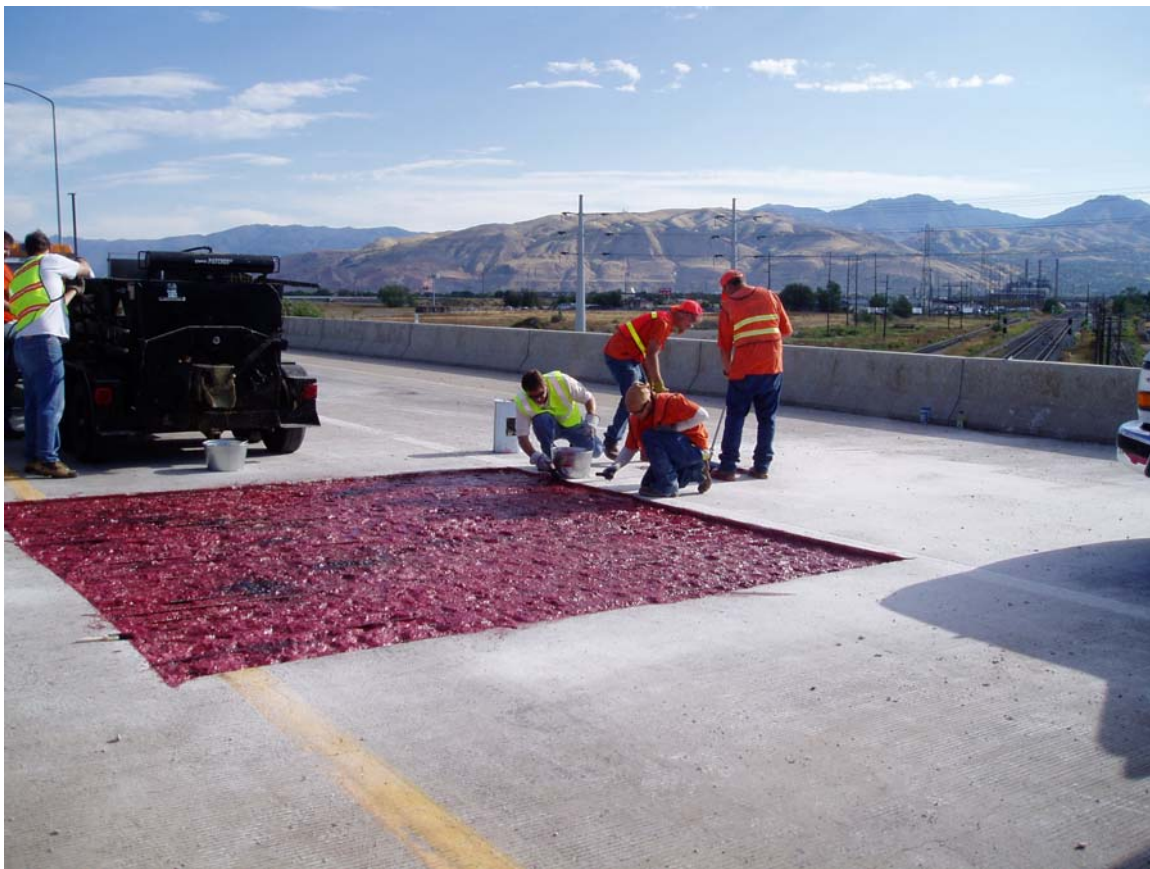
All edges of the patch area were also covered with the primer.

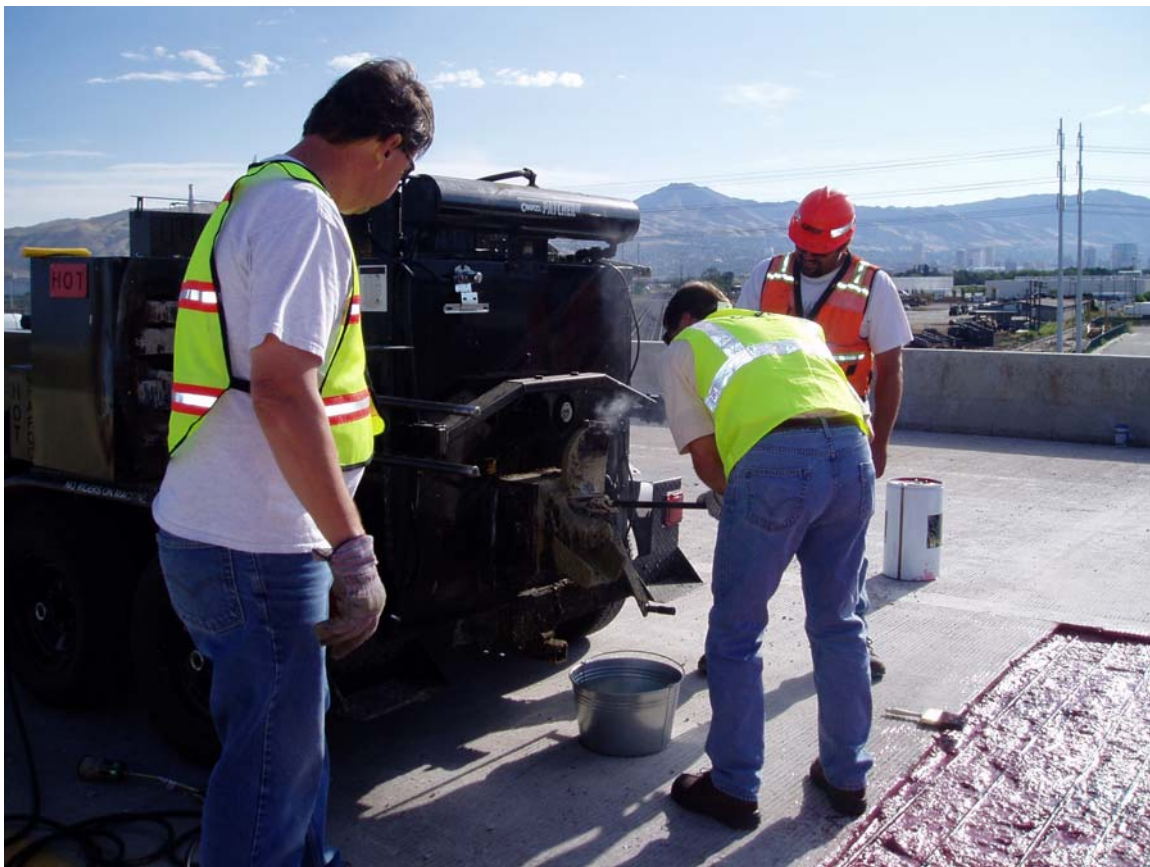
The initial "plug" was emptied into a bucket and dumped back into the mixer to be reheated.

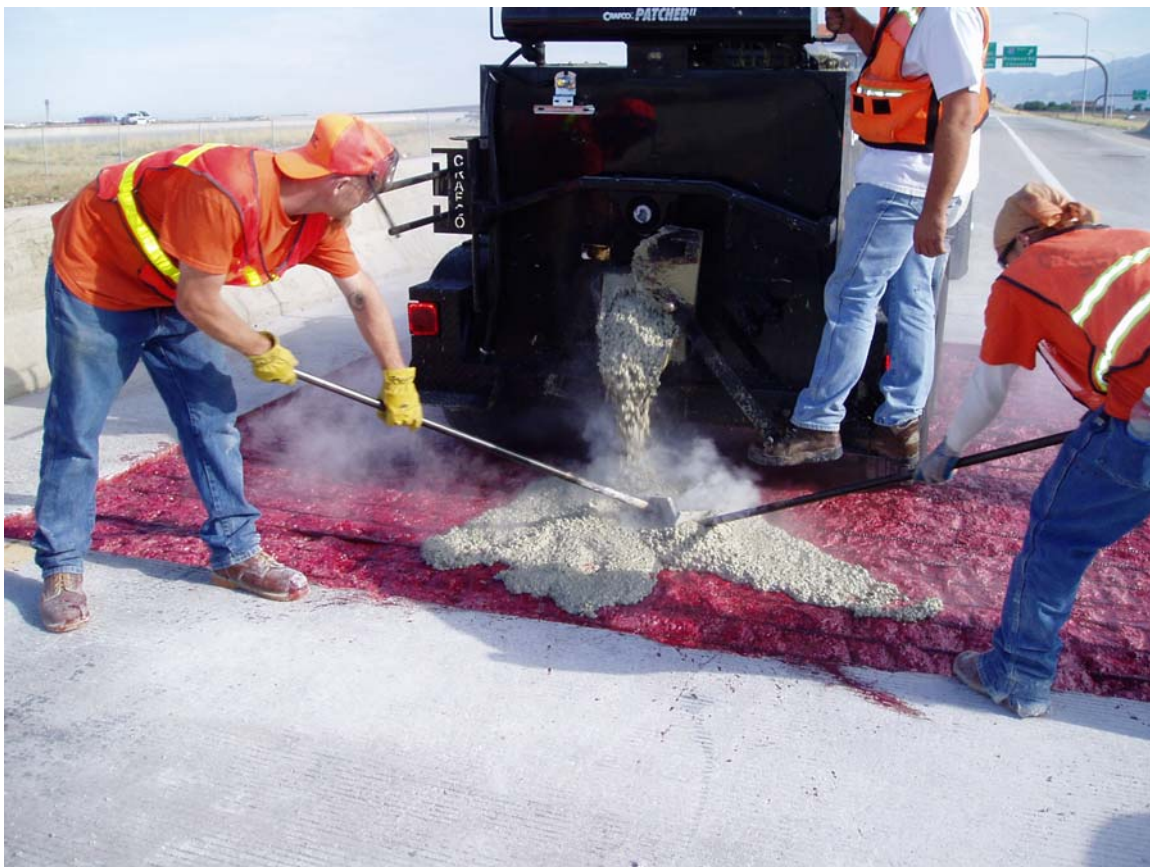
Heated spreaders were used to push the polymer into place where it began self-leveling.

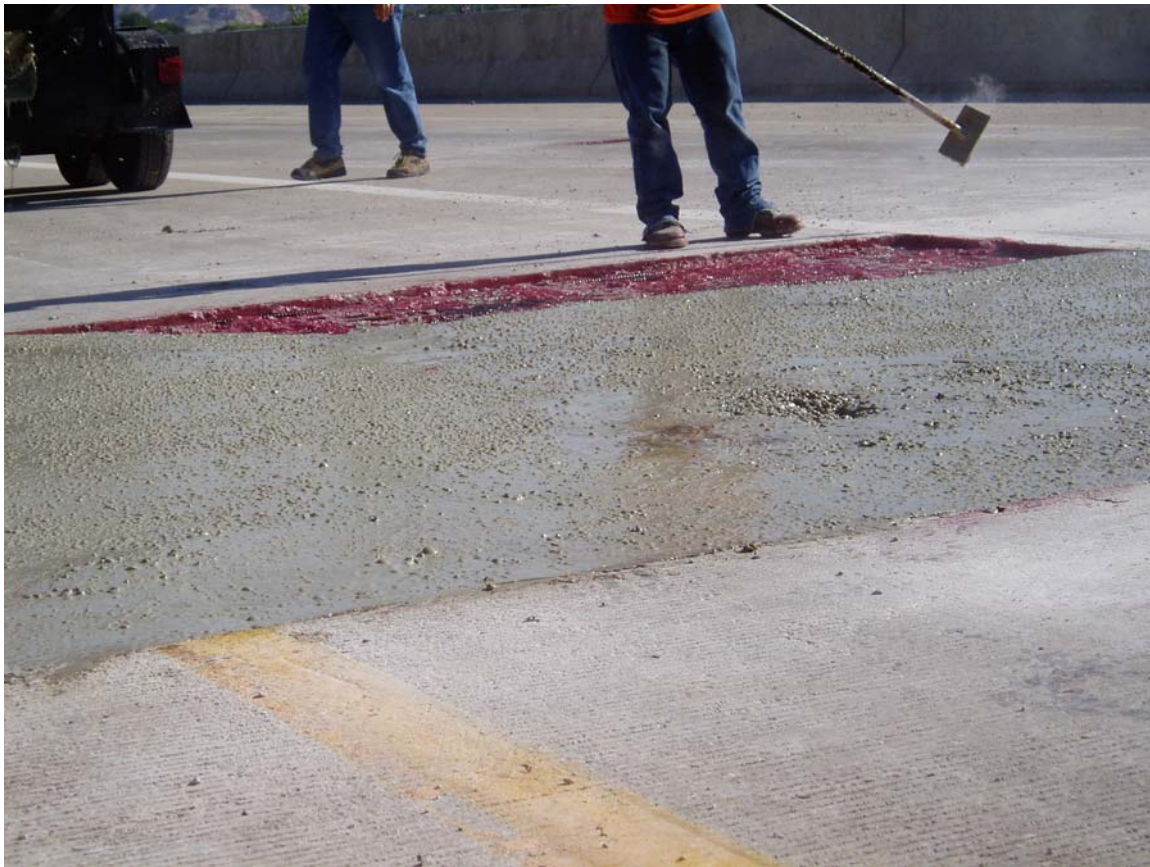
The polymer “sets” quickly as it cools. This makes it difficult to push into place over a large area.

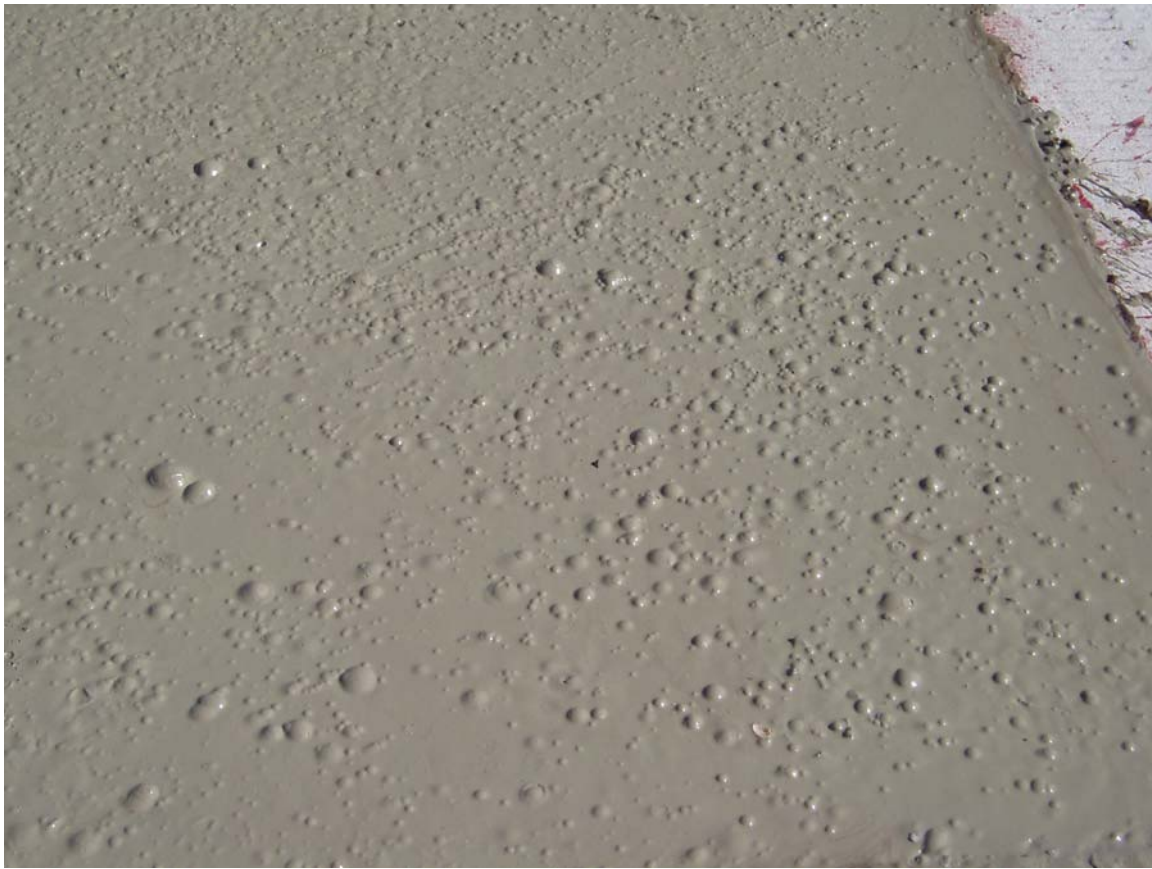
Bubbles were present in the hot polymer.

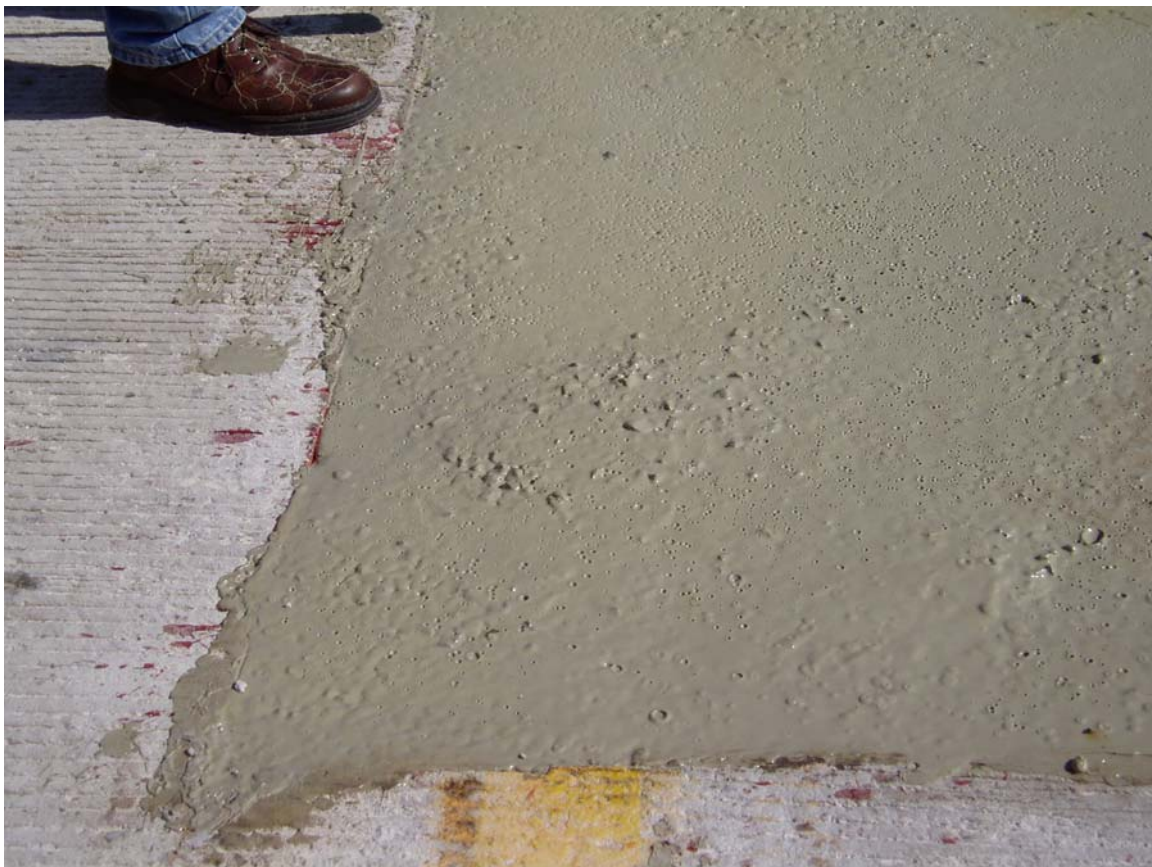
“Sanding” of the polymer could not begin until all the bubbles had popped.

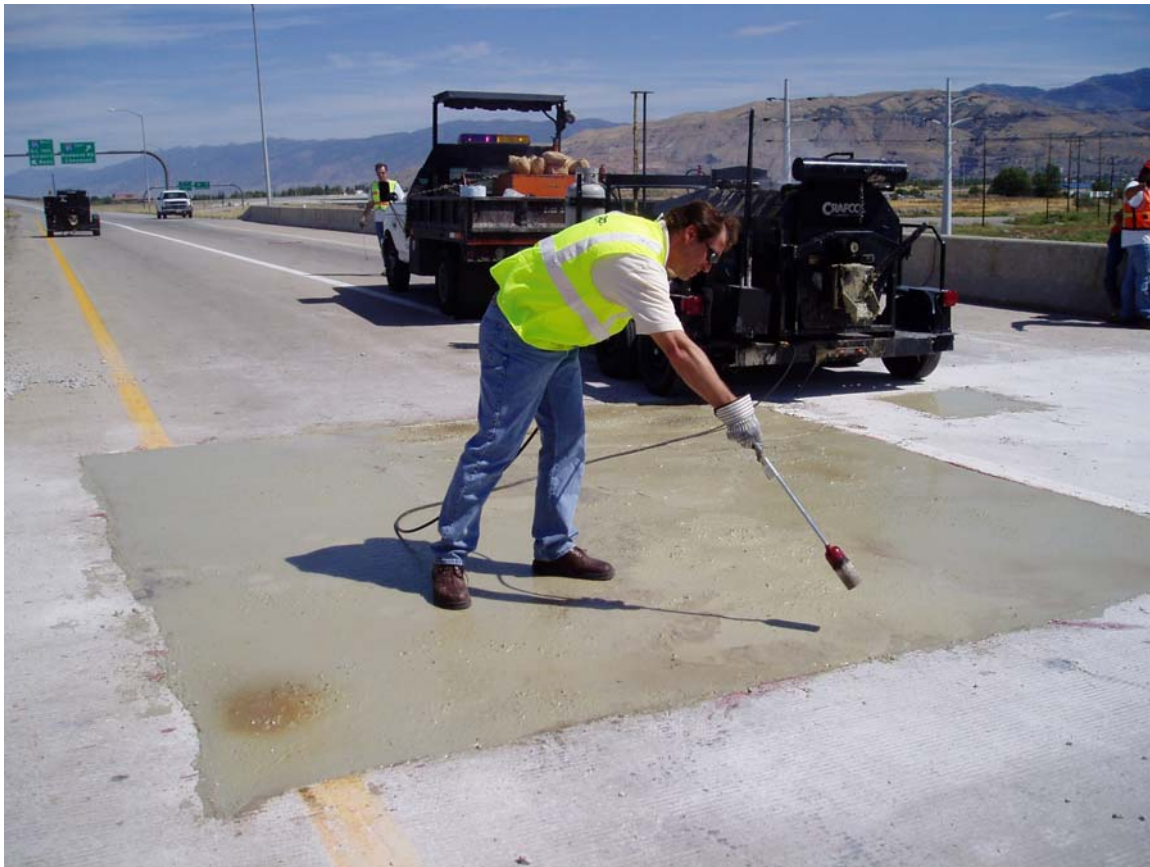
The polymer was heated to help the last bubbles pop and warm the surface for the application of the sand.

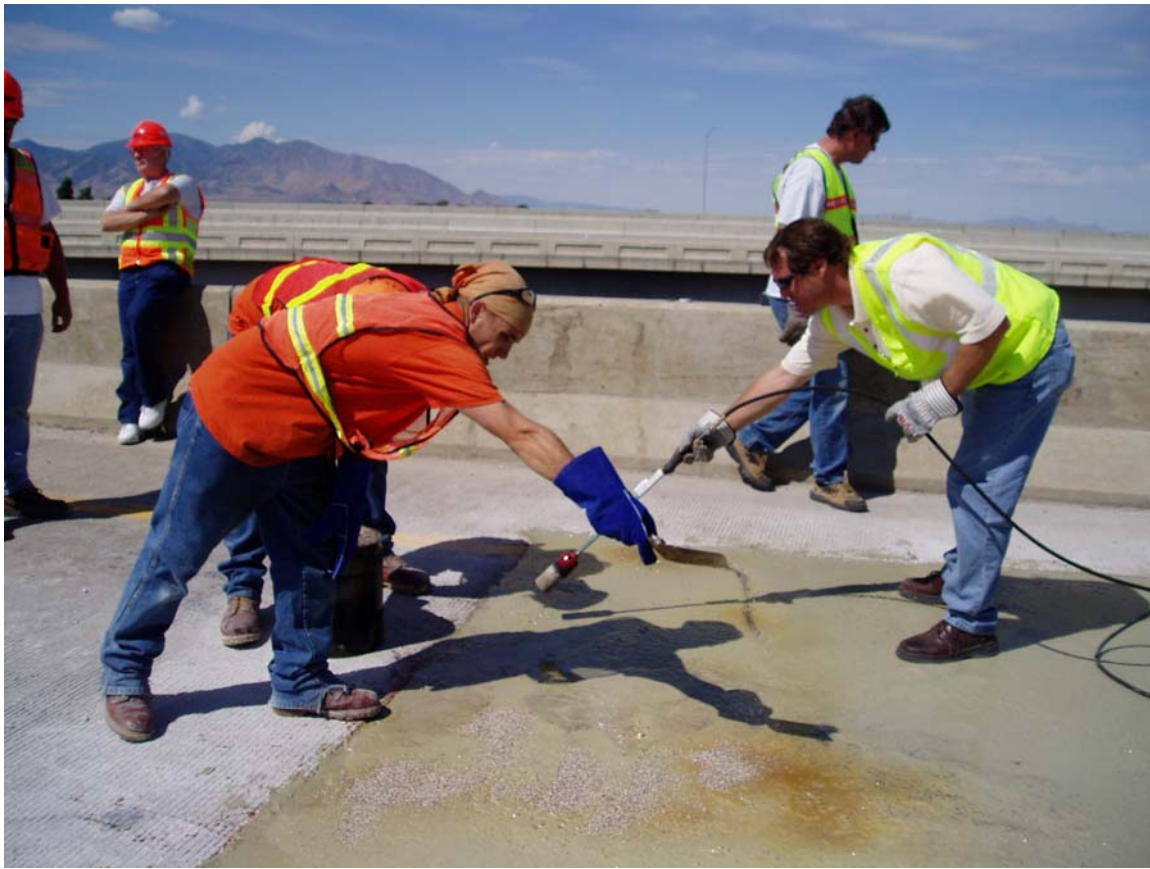
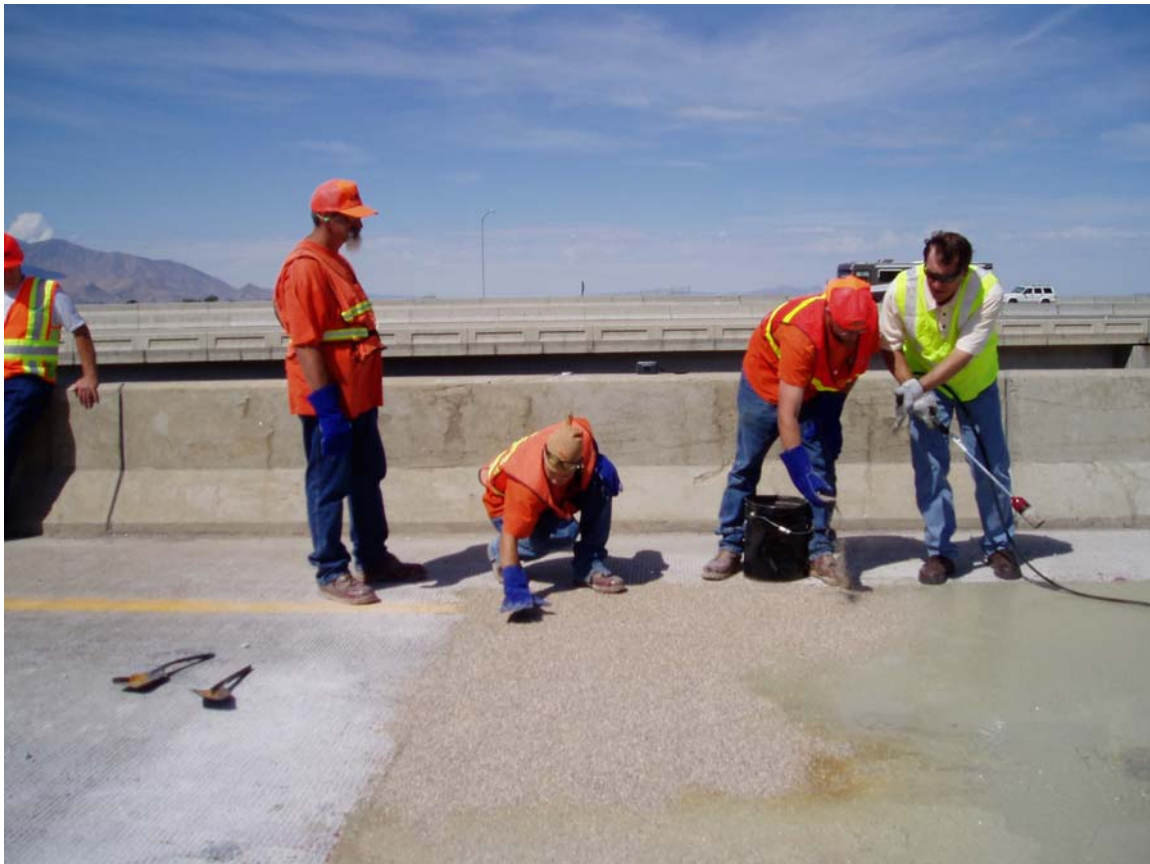
The sand was patted into place to assure bonding.

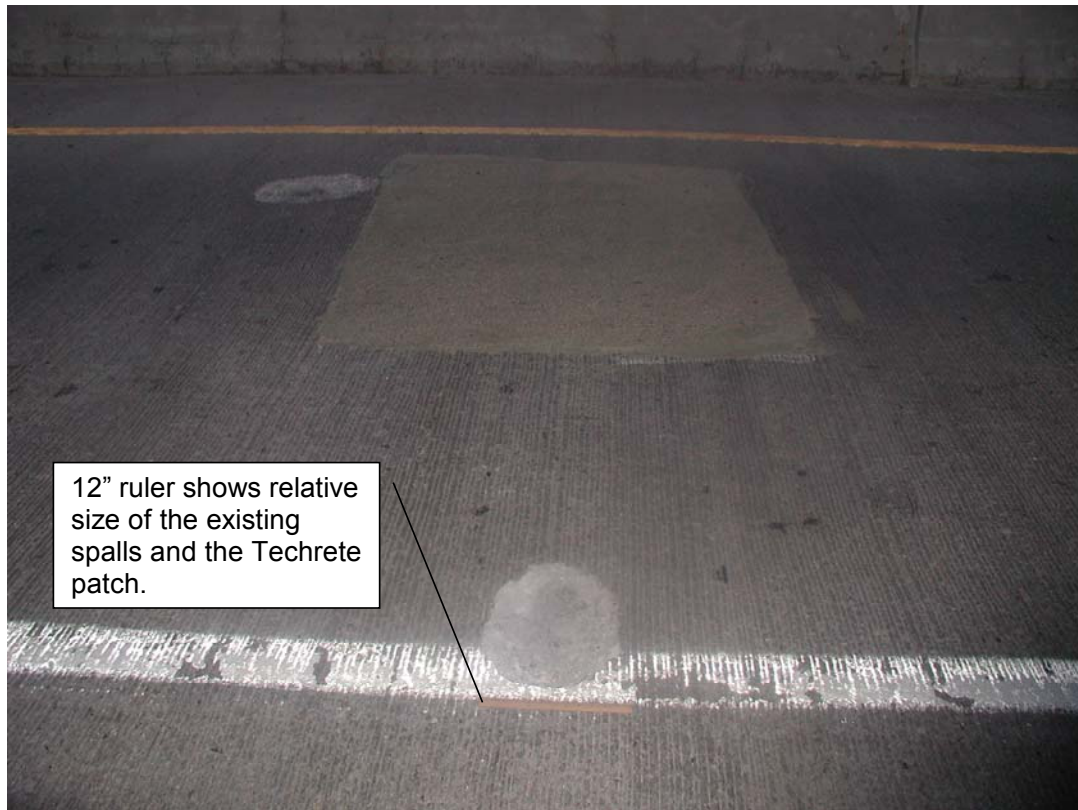
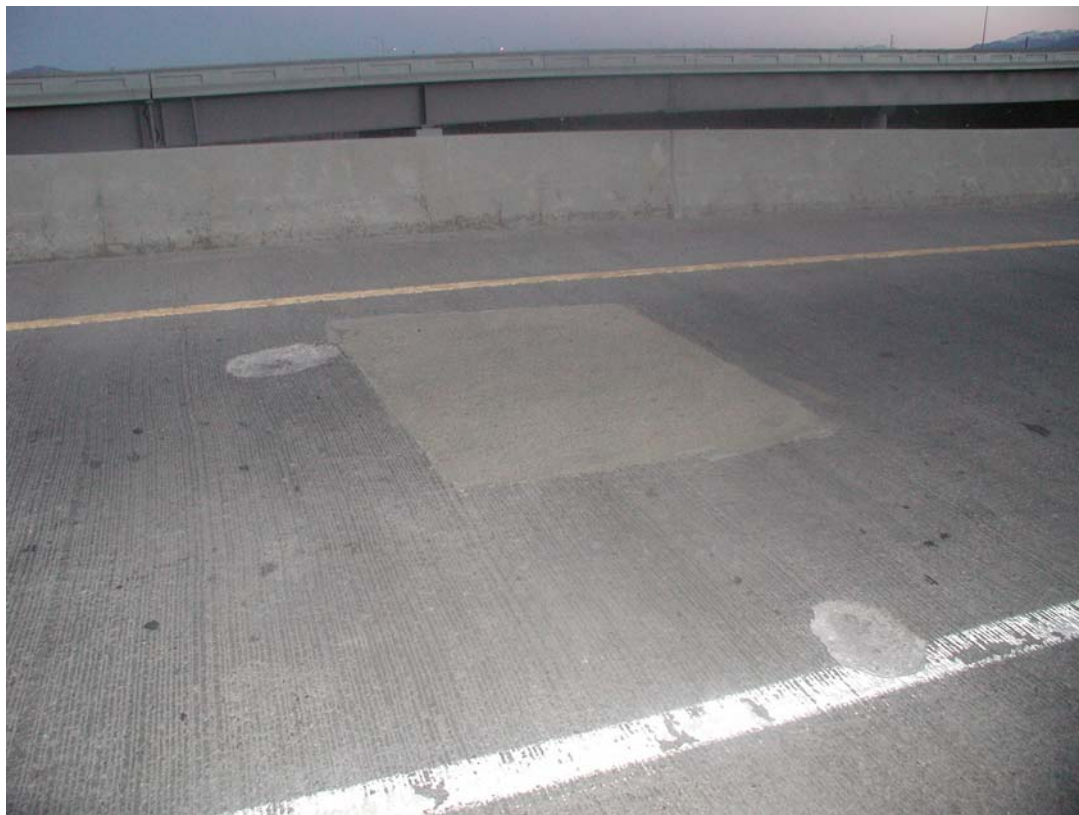
The following photos taken in the spring of 2005 show that the patch seems to be intact.

Techrete patch appears to be intact with no evidence of degradation
